Monitoring Data Record

Project Title: R-2231CB (US 220 Bypass) COE Action ID: 199400590
 Stream Name: UT to Big Mountain Creek (Site 6) DWQ Number: 000874
 City, County and other Location Information: Montgomery County, US 220 Bypass (Station 268+00 LT.
 Date Construction Completed: water was turned on 9/19/05
 Monitoring Year: (1) of 5
 Ecoregion: _____ 8 digit HUC unit 03040203
 USGS Quad Name and Coordinates: _____
Rosgen Classification: _____
 Length of Project: 253' Urban or Rural: Rural Watershed Size: _____
 Monitoring DATA collected by: M. Green and J. Young Date: 7/24/07
 Applicant Information:
 Name: NCDOT Roadside Environmental Unit
 Address: 1425 Rock Quarry Road Raleigh, NC 27610
 Telephone Number: (919) 861-3772 Email address: mlgreen@dot.state.nc.us
 Consultant Information:
 Name: _____
 Address: _____
 Telephone Number: _____ Email address: _____
Project Status: Complete

UT Big Mountain Creek (Site 6)

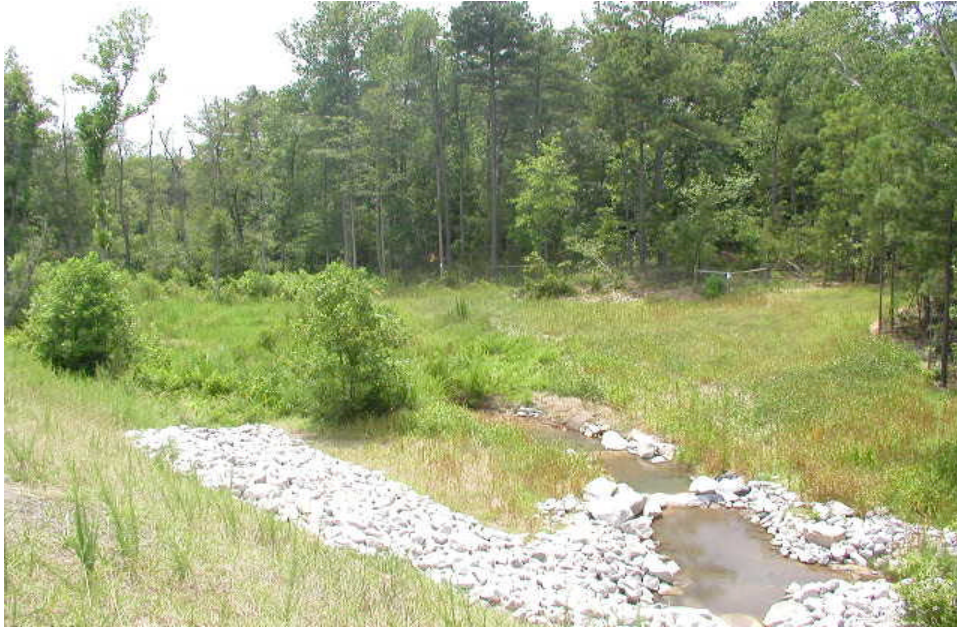
Overview of Site Looking Downstream
